RE: Site Inspection; Star Stone Quarries, Inc.; Santa Barbara Quarry, S/013/006, Duchesne County, Utah

Date of Inspection: August 20, 2002
Time of Inspection: 7:20 to 7:30 p.m.
Conditions: Mostly clear, 70's
Participants: Paul Baker, DOGM

ATTACHMENT
November 20, 2002
Photographs
S/013/006, Santa Barbara Quarry, Star Stone Quarries

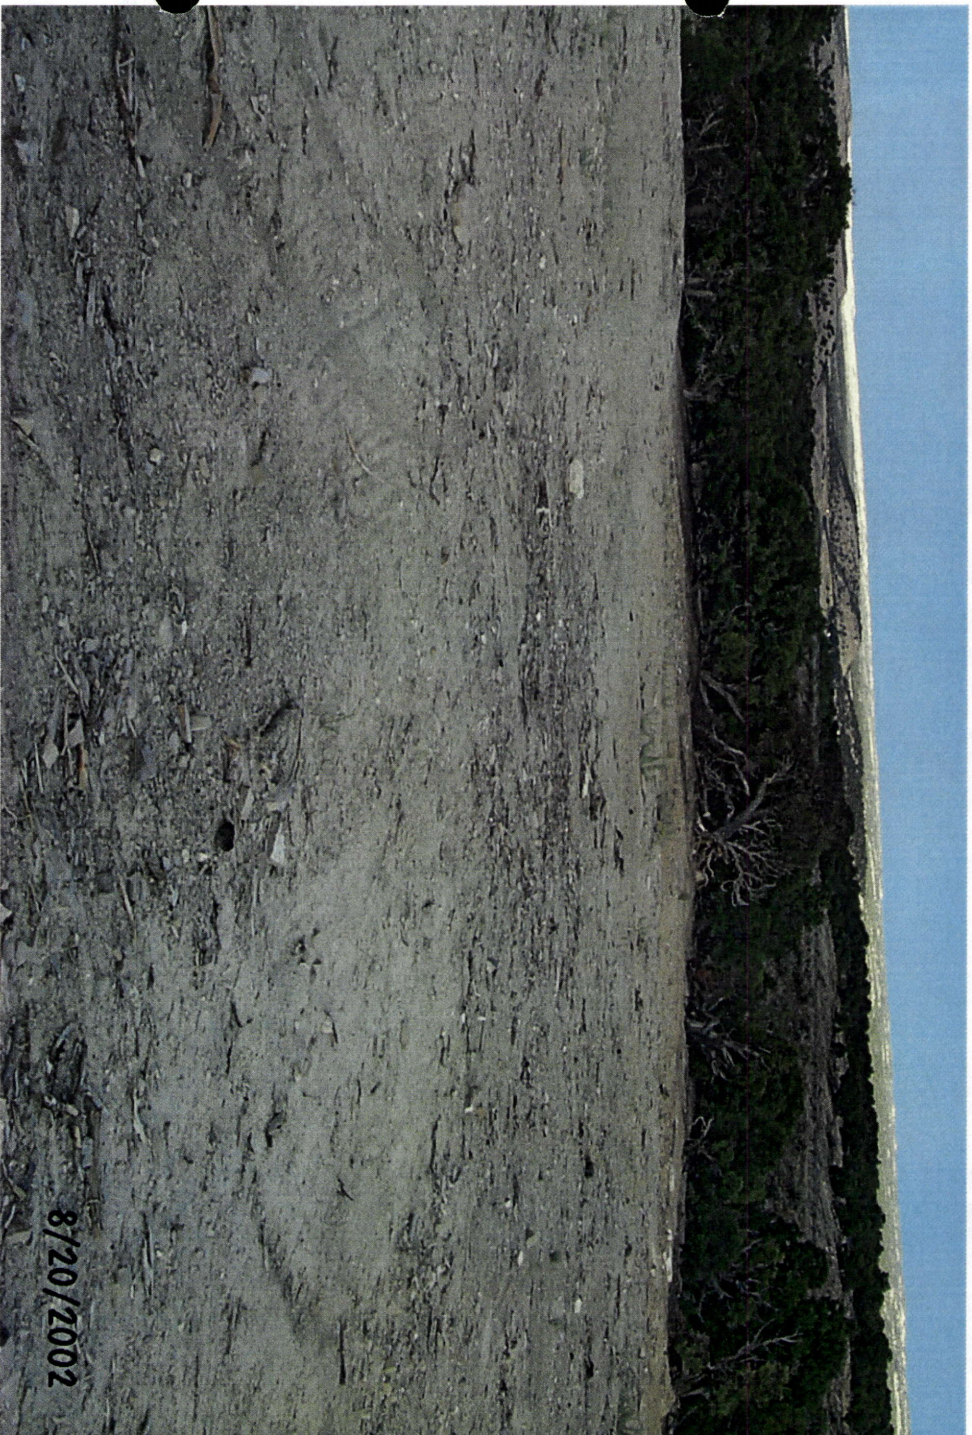
I estimate there is less than one percent vegetation cover (see Photo 1). Species observed include Ephedra, big sage, rabbitbrush, a bluegrass, and halogeton. Except for the halogeton, all of these appeared to be plants that survived the disturbance rather than ones that grew from seed. Other than this, the site appeared as it did last spring.

Photo 1. Santa Barbara Quarry disturbed area. Note the lack of vegetation.

The area has had some good late summer and fall rains, and if there was still viable seed, it should have germinated. I recommend that the operator check to see what vegetation is growing now. If there is very little, the area should be reseeded this fall because there is probably little viable seed remaining.
